Appendix 5-J

WILD HORSE RIDGE

**BLIND CANYON SEAM PAD
AND CONVEYOR ACCESS ROADS**

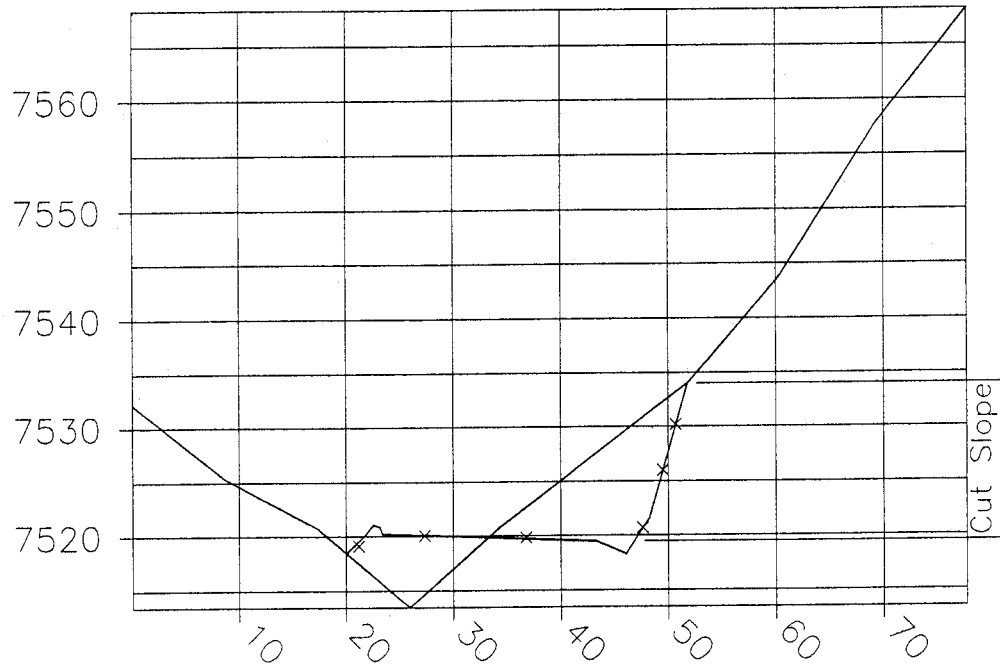
STATION 6+00

UPPER CONVEYOR ACCESS ROAD

— PRE-MINING/POST MINING
* * * OPERATION
